NASA
Spaceport Engineering and Technology Directorate
Labs and Testbeds Division
Kennedy Space Center, Florida

KSC-MSL-0468-2001

SUBJECT: Failure Analysis of the Multi Mission Support Equipment (MMSE) Cable electrical flashover at the Space Station Processing Facility (SSPF)

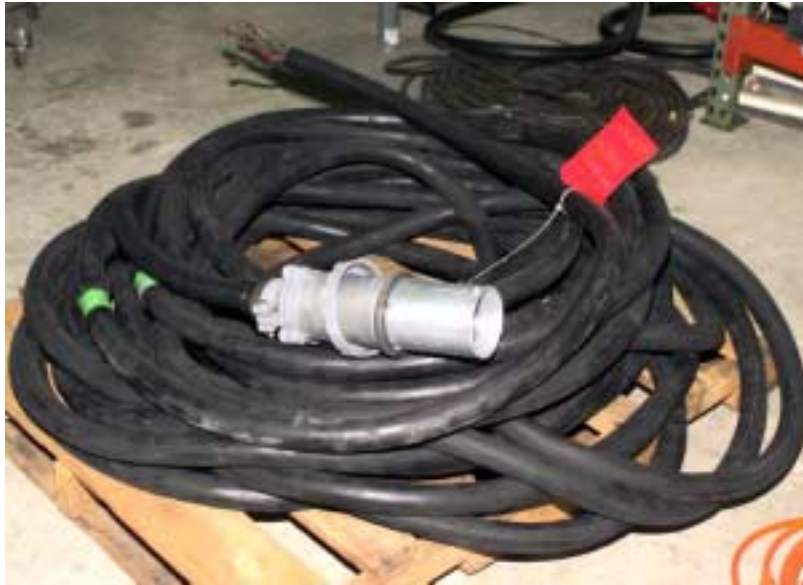
Figure 1

The MMSE Transporter Shore Power Cable, C-1 (see Figure 1), experienced an electrical flashover when the Space Station Processing Facility (SSPF) receptacle was initially energized thru breaker S1-E03-039. Several inadequacies in the cable assembly construction, allowed twisting and normal manhandling of the cable assembly (during plug connection to the receptacle) to apply stress to the inside cable conductors which caused them to work loose from their pressure clamp terminations and become free to reposition inside the connector. After closing the circuit breaker, electrical arcing between two conductors was evident, after one came loose. The arcing caused a "flashover" that vaporized part of the loose ground potential wire and caused subsequent damage to the connector assembly. The force of the flashover caused the cable to separate (see Figure 2) from it's power plug connected to the SSPF wall receptacle.

Cable C-1 in its entire length, with undamaged Russell-Stoll Plug attached and without missing Pyle-National Plug that was separated from the cable assembly, due to force of flashover at time of failure. Magnification: oblique view.

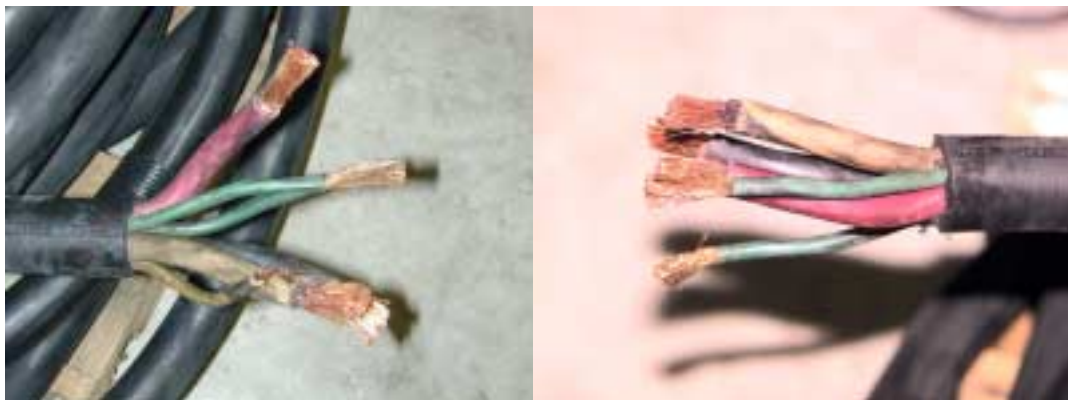
Figure 2

Cable end that Pyle-National plug was blown off of. Note that strands of yellow-looking ground plug (left-most photo) was the same thickness as the two other green ground conductors (all three previously inserted into one plug terminal clamp), but most of its strands are burnt off and missing. Conductors show burns on insulation indicating that arc-over occurred which was observed as a "flashover." Magnification, left photo: oblique view; right photo: 0.28X.

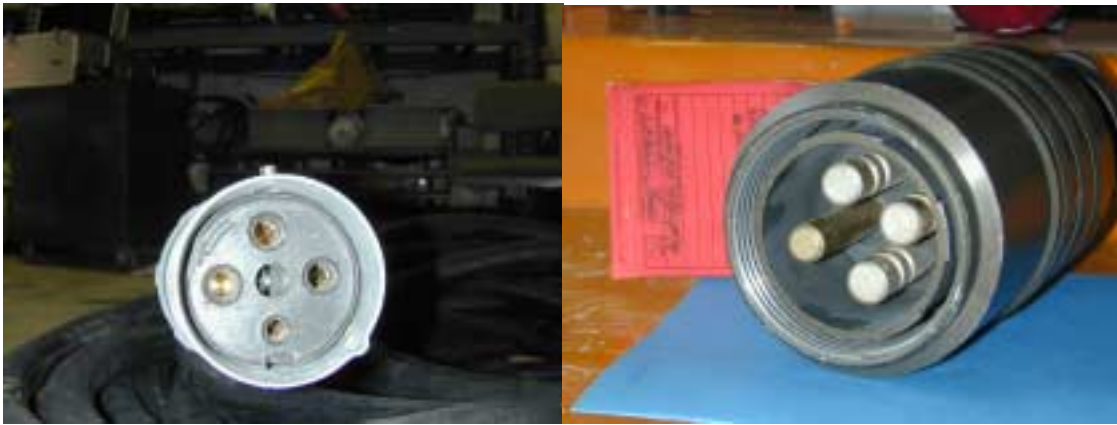
Figure 3

- 2.2 The Pyle-National plug (see Figure 3, right photo & Figure 5, left-top photo) is a large, heavy duty plug designed for use in hazardous environments (but not used in this situation at a hazardous location). The plug uses an internal spring-loaded mechanism that drives the phase pins into the mating receptacle sockets (see Figure 3). Due to the force required to overcome this spring tension, two technicians are required to connect it to a receptacle: one technician threads the plug onto the receptacle and the other technician helps push up and maneuvers the cable to relieve any binding which may occur. Just prior to the SSPF power transfer, the subject cable assembly was used to transfer power at the Operations and Checkout (O&C) Building with the same personnel and equipment without incident . The cable was fabricated and labeled per drawing 79K25959-1 and has been in service since then.

Connectors from both ends of failed Cable. Female Connector in left photo was tested in Canister Rotation Facility (CRF). Pins, from bottom inner key, were labeled pins "4" Clockwise (CW) thru "1" in write-up. Blown-off Male connector is shown in the right photo. Magnification: oblique views.

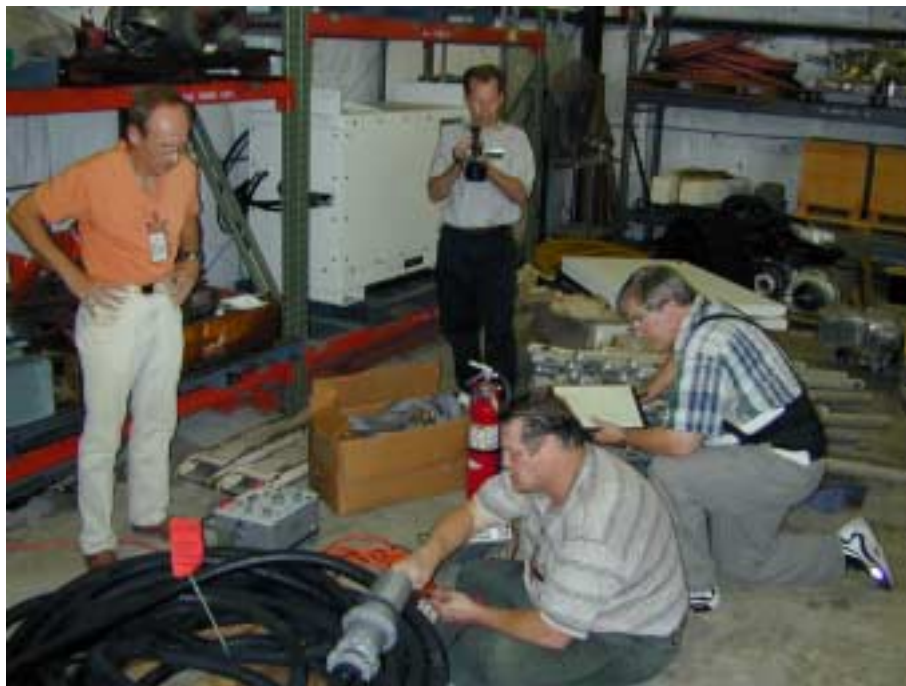
Figure 4

- 3.3 Using a Hewlett Packard (HP) Multimeter, the following measurements (see Table 1 below) were taken from a seated position on the CRF floor (see Figure 4). Refer to Figure 3 (left photo) for orientation of the connector measurements. Connector pins were measured from the bottom inner keyway & labeled CW as pins "4" thru "1".

The results indicated that the individual conductors were isolated from one another. This reduced the possibility that a short from one conductor to another had caused the failure and put more emphasis on the connector being the failure mechanism, rather than the cable.

Photo documentation and field resistance checks (case-to-pin and pin-to-pin) of the cable end, at the Canister Rotation Facility. Magnification: oblique view

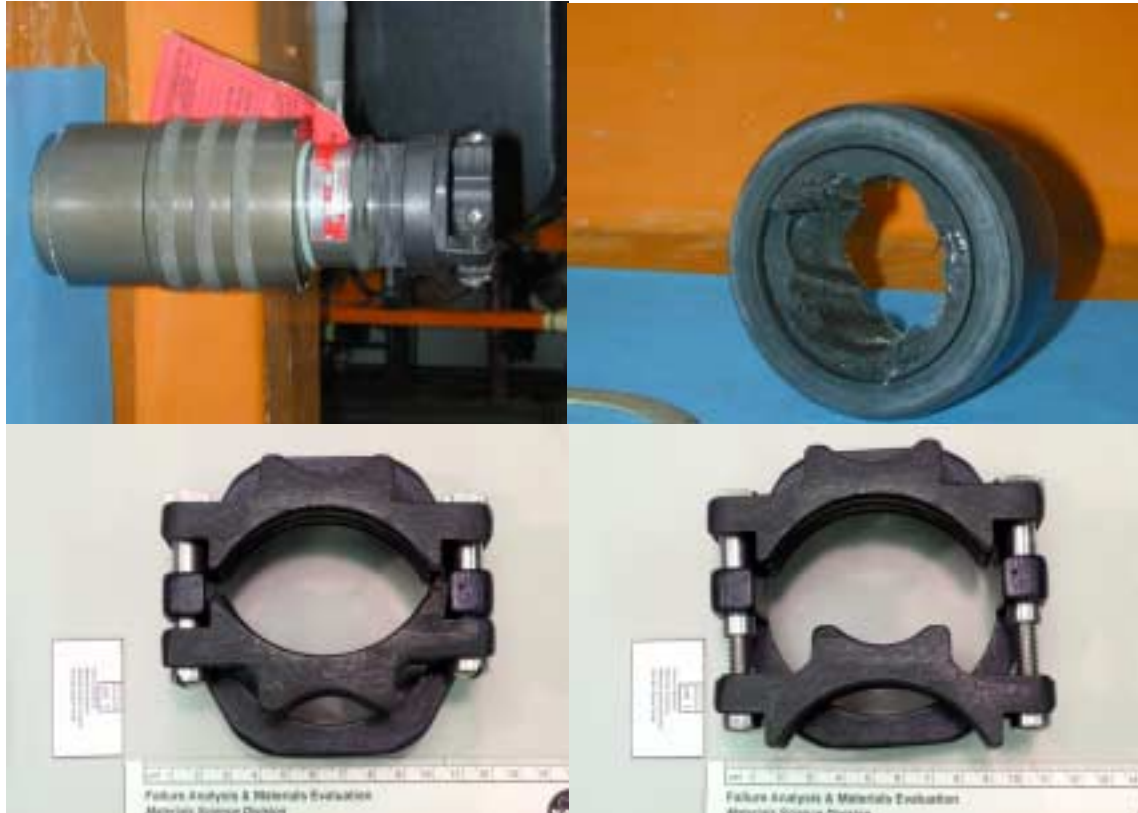
Figure 5

- 3.2.1 The cable (outside diameter of 1.625 inches) was smaller than the grommet (P/N 38 with an inside diameter of 2.25 inches) provided; therefore, a makeshift inner grommet-extension-filler was fabricated using stripped outer rubber insulation from a scrap cable. The makeshift grommet was irregular on its inside and split apart, to fit inside the grommet of the makeshift assembly (see Figure 5, top right photo). This may have allowed moisture intrusion; and certainly, did not put sufficient pressure against the cable to hold it tightly. Also, if the connector had been used at a hazardous location, it would not provide a proper seal per NEC standards, or any other standard.

- 3.2.2 The cable clamps were adjusted to a position that would provide the greatest circumferential cable contact area (see bottom-left of Figure 5); however, that configuration did not apply adequate force to keep the

cable from rotating. The adjustable clamps could have been reconfigured (see Figure 5, bottom-right), to provide minimal-contact-area (higher-force) upon the cable, but that had not been done for the failed connector assembly.

Pyle-National plug is shown with adjustable clamps on its' far right side (top-left photo). The top-right photo shows "manufactured" grommet and "makeshift" (inside) grommet. This was one obvious reason that the cable was not held tightly in the connector. Magnification top left: 0.18X, right: oblique view.

The second obvious reason that the cable was not held tightly was the configuration of the adjustable clamps. The bottom left photo shows the Pyle-National plug's adjustable clamps as they were assembled at the time of failure. The bottom right photo shows the adjustable clamps configured for an appropriate cable tightness (the desirable configuration with the screw assembly lengths chosen) to help prevent a similar future failure. Magnification: 0.43X, in both bottom left and bottom right photos.

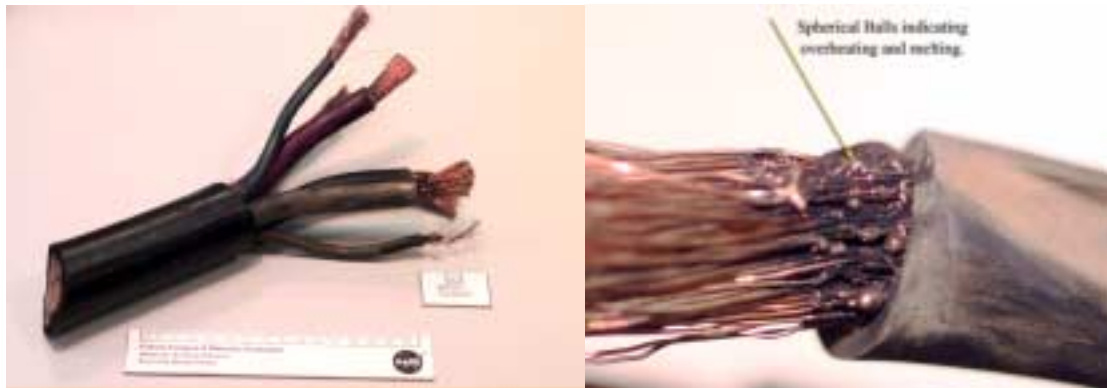
Figure 6

3.6 The cut-off cable end (see the left half of Figure 6) was photographed along with the connector and the following visual observations were made:

3.6.1 The individual conductor strands of copper had spherical balls of copper (see Figures 6, 7 & 8) near their insulation interfaces and charred burn marks indicating massive overheating caused by an apparent short to all phase conducting wires in the 480 Volt cable connector. It was also noted that the molten balls were above the area of each wire where its individual clamp left witness marks. The probability that all three phases could become shorted together by one loose ground wire is not likely; therefore, a different failure mechanism was sought.

Cable cut off (left photo), for laboratory analysis. Magnified photo at right, shows that strands of copper had evidence of overheating / melting. Magnification: left photo, oblique view. Magnification: 1.82X, right photo.

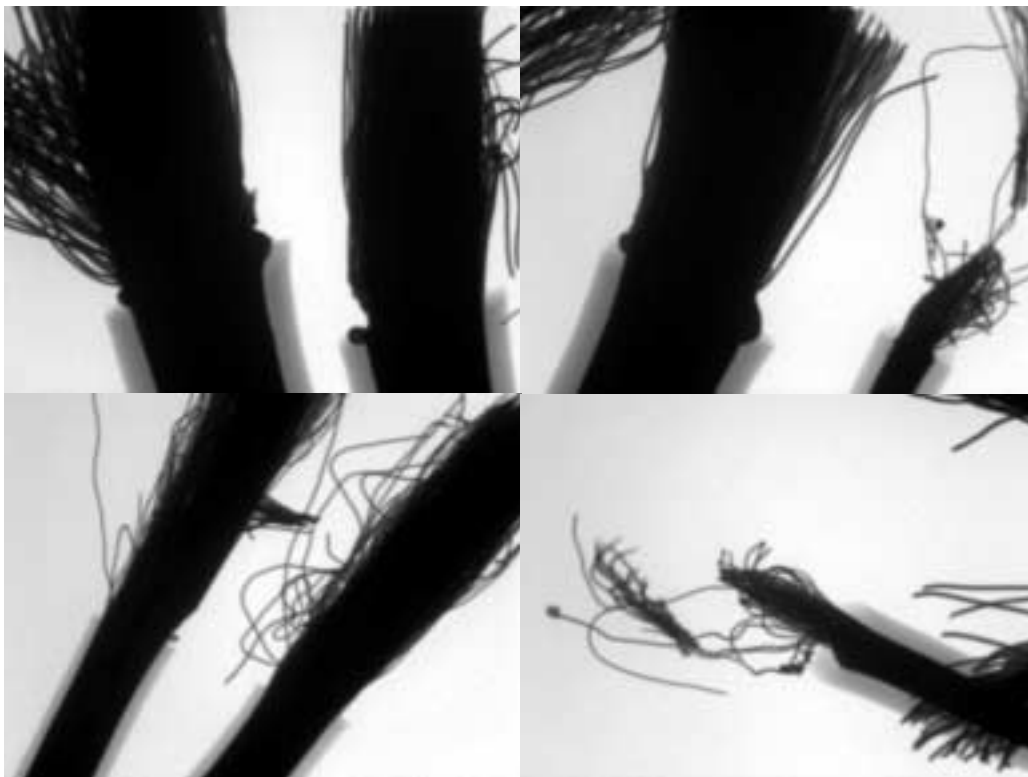
Figure 7

- 3.6.2 Damage on the smaller "yellow" ground wire (most of the strands were burnt off) (see Figures 6, 7 & 8), as well as, a spherical melted copper ball (see Figures 7 & 8) on its end indicates that the short most likely started with this conductor.

- 3.7 The cable end was X-rayed (see Figure 7). The X-ray images depicted that the melted coppers balls were concentrated near the intersection of insulation to bare-copper. One spherical ball was on the end of the yellow ground conductor suggesting that the bottom of the conductor had loosened and contacted the conductor strands of one of the 480 volt phase wires. Also, since it was the most heavily damaged, it indicated that this was the conductor where the major shorting flashover was initiated. What followed was an observed "flashover" that caused the cable to physically separate from its connector that was attached firmly to the wall.

X-rays show melted coppers balls were concentrated near the insulation on all except the most damaged ground conductor which obviously came loose: causing shorting and melting to occur. Magnification: oblique views

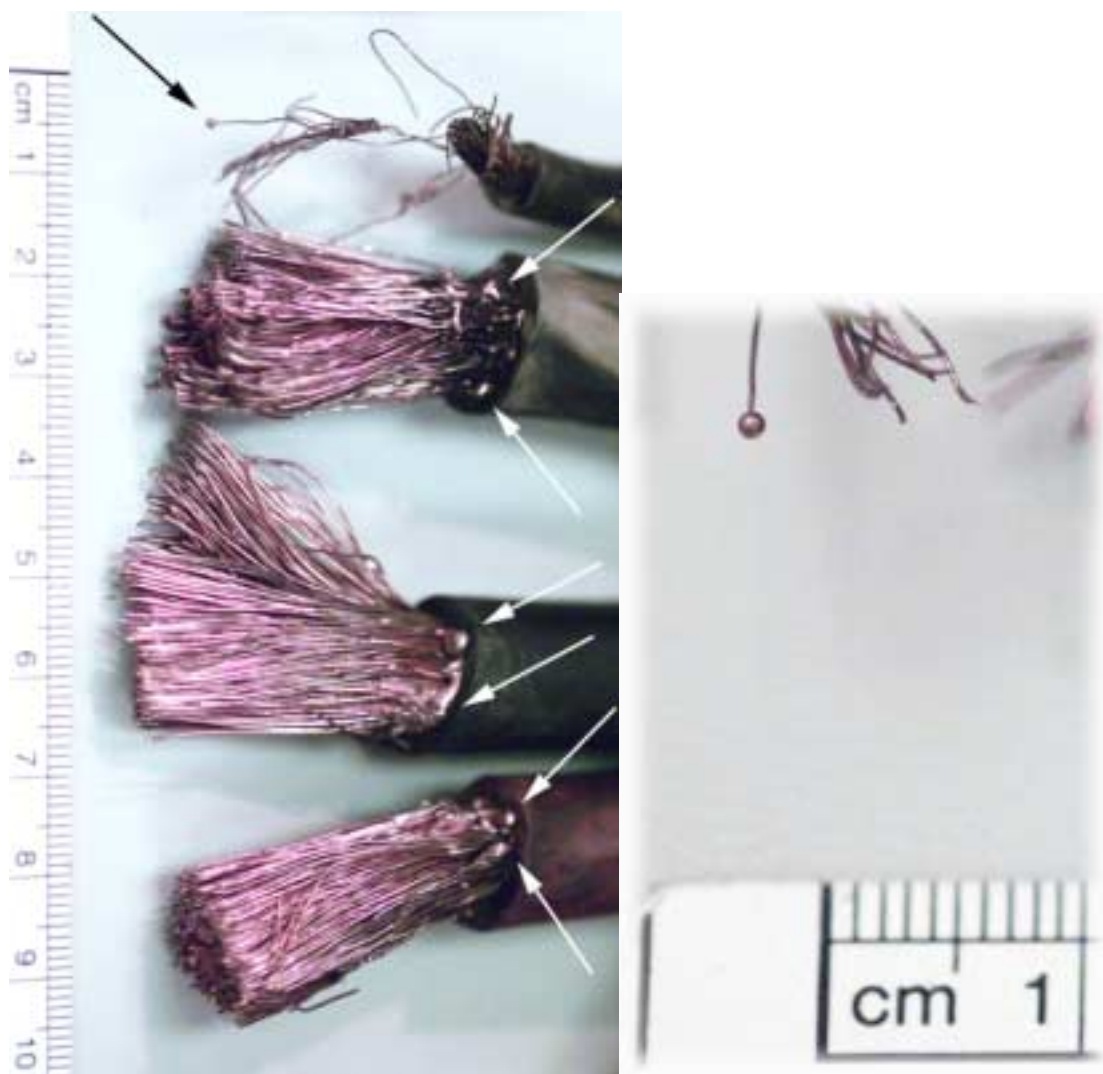
Figure 8

Arrows indicate the locations of spherical balls of copper indicating massive overheating caused by an apparent short to each phase of the 480 Volt cable. Damage (left photo) & spherical melted copper ball (magnified on right photo) on small ground wire (most of the strands were burnt off) indicates that one of the three smaller ground conductors received the most damage from shorting (indicating that the short started on this conductor). It is assumed that this wire came out from its clamped terminal and contacted another loose terminal, when the cable was twisted; thereby, creating the failure. Magnification: 1.37X, left photo. Magnification: 3.75X, right photo.

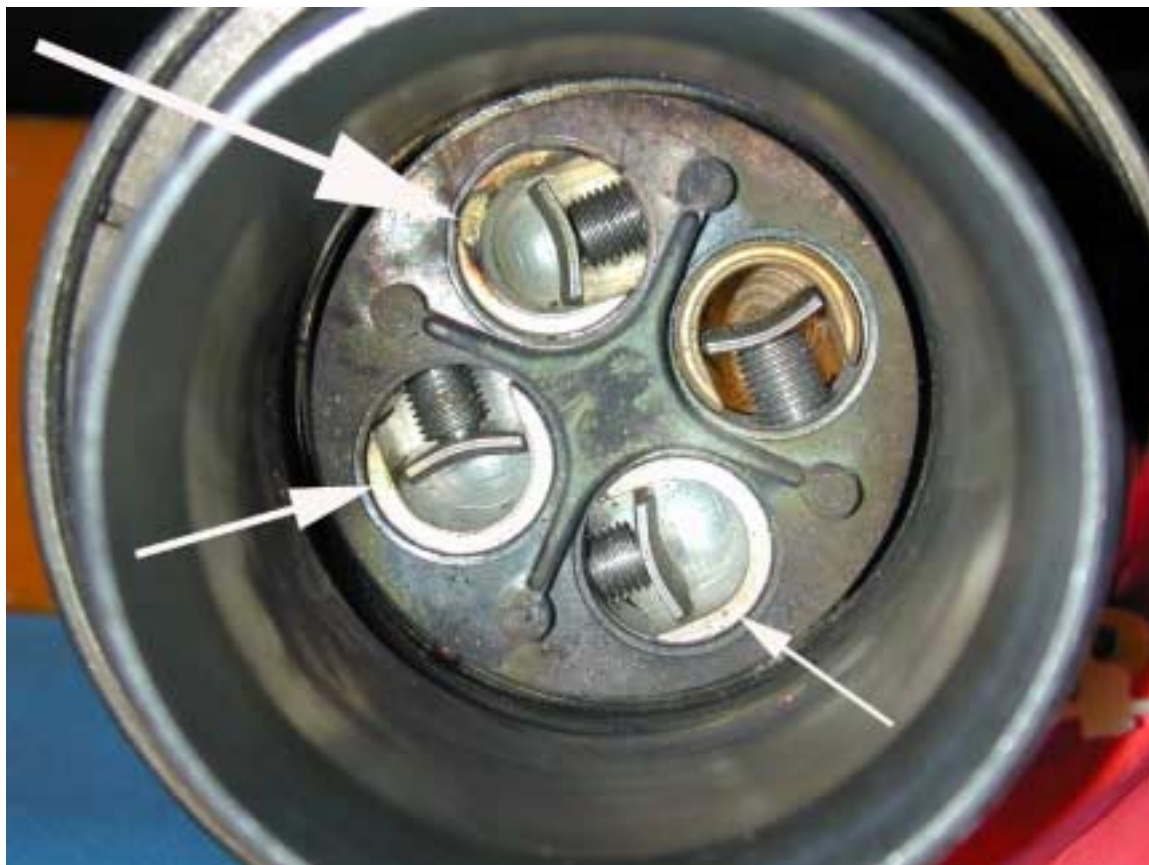
Figure 9

- 3.6.4 There are burns inside the connector (see the arrows in Figure 9). Note that the clamp hole to the left of the darker hole, has a large area of damage caused by arcing. Also, each successive counterclockwise clamp hole has less damage.

3.14.3 The arcing between equal potential surfaces (described in 3.6.4 above) can be explained as arcing between the wires and the connector, as the wires were ejected from the cavity under current load. The most arcing can be seen (see Figure 9) next to the clamp cavity (pin 1) where the ground wire first shorted out to the first phase voltage wire. This shorting caused an ionization and the resulting vaporization, melting, embedding and deposition of/to the other phases would have lasted very briefly: so briefly, that the other two phases did not have as much time to draw the current that was drawn by the initial phase wire short circuit. This effect caused less damage to those two termination holes as the wires were ejected from the expanding ionization cavity.

Photo shows terminal clamps in blown-off connector. Notice that one of the pressure clamp holes has a brown coloration (a different material). This pin is the ground pin hole that probably was the flashover point of origin. The Star in the middle is an insulating barrier that should have prevented a short circuit if the wires were properly stripped, or not loosed, where they were above the barrier mechanism. Notice the damage caused by current arcing (see arrows). Magnification: 1.10X.

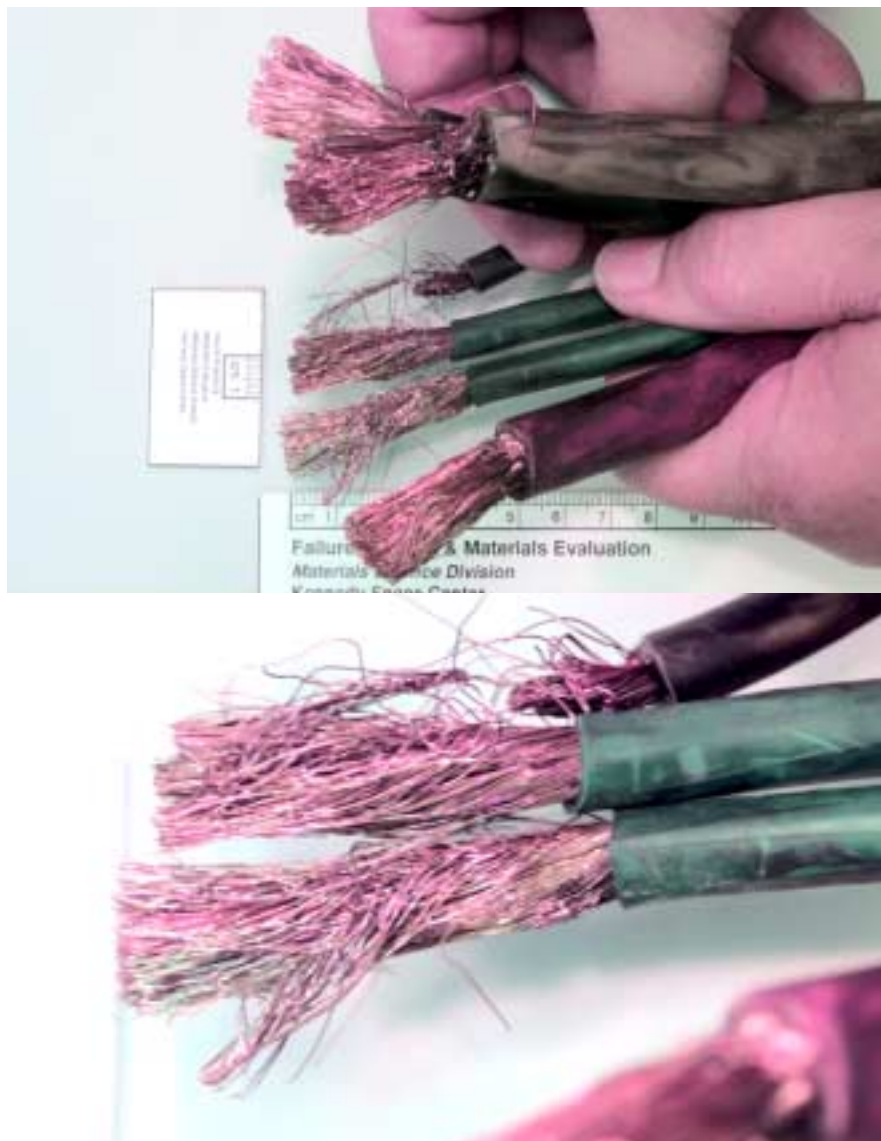
Figure 10

- 3.8 Closer analysis (see Figure 10) of the individual conductors of the cut-off cable end, revealed that each conductor had been cut off at unequal lengths and that the insulation of each conductor had each been stripped off at an unequal length (see Table 3 below).

Photos depict that the individual wires of each conductor had not all been cut off at an equal length. They also depict that the insulation had not each been stripped off at an equal length. If properly cut to length and if properly stripped of insulation at equal lengths, then there would be less of a chance of shorting if one of the conductors were pulled loose. Also, the three small grounding conductors should have been mechanically locked together (possibly by twisting, braiding or crimping) to prevent one of them from pulling loose. Magnification: 0.60X, top photo, 1.56X, bottom photo.

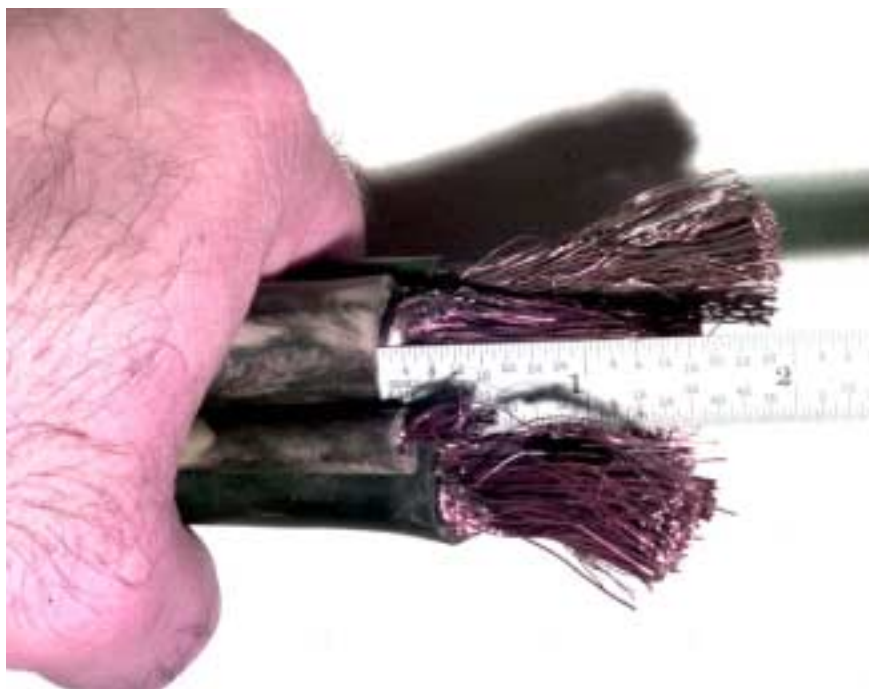
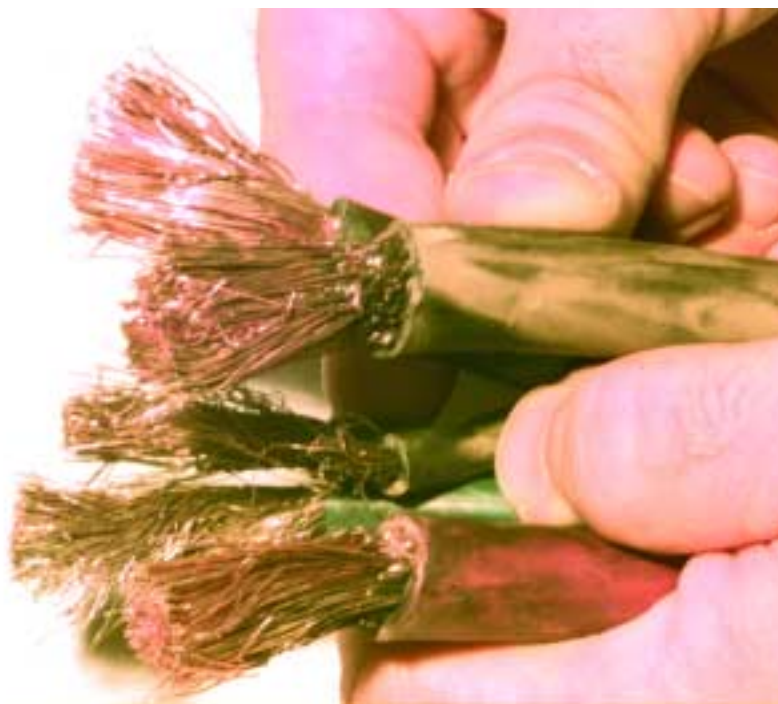
When the cable wires (see Figure 11, top photo) are bundled together tightly, or arranged approximately as they would be inside the connector (see Figure 11, bottom photo) the disparity of the uneven stripping is quite notable. This is because, although the length of the stripping of each wire varied by just 19/64 ths of an inch, the ends of the wires were cut off at different lengths. It can be seen (comparing Figure 11 with the Table 3 above) that when the longest green ground wire is bottomed out in a clamp hole that:

3.8.1 the bare copper is just the length of the clamp hole depth,

3.8.2 the other wires could not be bottomed out, since they were trimmed bare of insulation close to the length of the clamp hole depth (see table). Subsequently bare copper would be exposed above the top of the clamp hole and possibly above the "star" barrier, if they had been loose, as was one ground wire.

3.8.3 the white phase voltage wire (the one with the most molten depositions) would be in the cavity above the clamp retainer mechanism and just below the top of the barrier. Therefore, if a phase wire were not pushed in as much as possible or if it had slipped out a little (during rotation manhandling of the connector attachment) then it would be exposed where a loose ground wire could come into contact with it and generate a catastrophic short circuit.

When the internal cable wires (top photo) are bundled together tightly, or arranged approximately as they would be inside the connector (bottom photo) the disparity of the uneven stripping is quite notable. Refer to discussion in paragraph 3.8. Magnification: 1.13X in top photo, 1.11X in bottom photo.

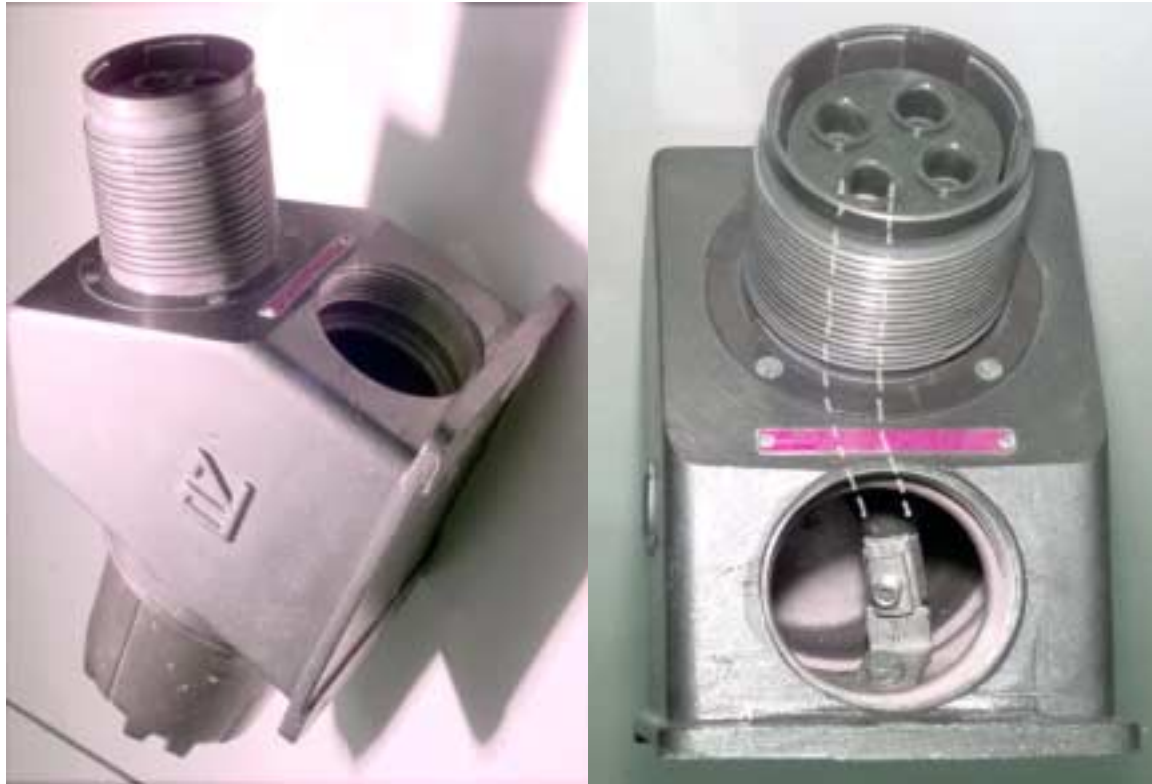
Figure 12

internal cables were cut off and the receptacle transported to the Electronic Failure Analysis Lab for analysis (see Figure 12). No visible damage was observed, but looking down into the female connector, a golden brown wall (similar to the connector cavity that was assumed to be the cavity or hole where the yellow ground wire was vaporized) was evident. Looking thru the lower connector opening (see right photo of Figure 12), a ground lug is visible, which is traced to the female receptacle cavity labeled 4G. This verifies that that pin was the ground terminal. No damage was noted to the female terminal and the corresponding terminal in the male connector. The receptacle covers were removed and the individual inside wires were visually inspected by the investigator and customer. No indications of any damage, or any suspect conditions were noticed. Therefore, further investigation of this part was not deemed necessary.

The wall mounted Receptacle Assembly was not damaged and is shown here only for information. Looking thru the bottom connector assembly opening, you can see the grounding method and trace the ground cable to pin 4G of the receptacle's female connector that was attached to the male connector that had an internal failure. Magnification left photo: oblique view, right photo: 0.38X.

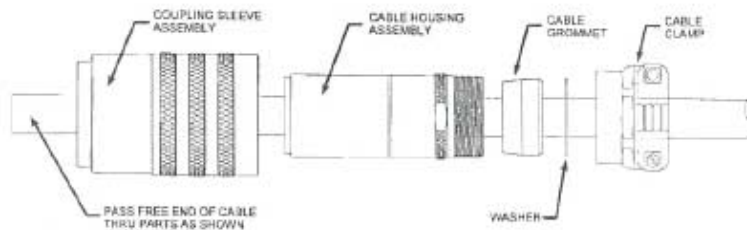
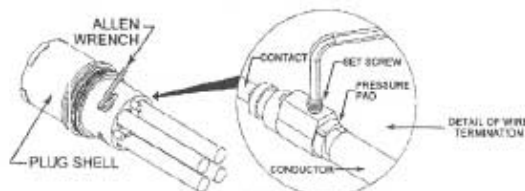
Figure 13

3.10 The "Vantage Technology GB & GD Series Assembly and Terminating Instructions" (instructions normally supplied with the connector parts during shipping) were reviewed (see Figure 13) and it also verified that the ground lug was pin 4. However, discrepancies were noted:

3.10.1 On page 2, "Step 3 – CABLE JACKET & WIRE STRIPING" (see Figure 12), it states, "STRIP CABLE JACKET, **3**" AS SHOWN"; but, the jacket was stripped twice as far (**6**") from the wire ends.

3.10.2 Taking measurements on the failed connector (from the bottom of a clamp connector hole to the top of the grommet), reveals that this distance is 6.641 inches. The grommet height is 1.141 inch. Since the cable was stripped back 6 inches, there was 0.500 inch of inside grommet surface that had no outer cable sheath to grip. This was another reason that the cable could easily slip, because its cable retention design methodology was compromised.

3.10.3 In the same step, the "NOTE" states, "The cable should be free of grooves or ridges in the area where the cable grommet seats on the cable. Smooth cable O. D. so that the cable grommet fits snugly 360 [degrees] on the cable. Also be sure that the correct grommet size has been ordered to fit cable." Looking at the makeshift grommet assembly (see Figure 5, top-right photo), it can be seen that the "correct grommet size" was not ordered, and that there was no way that the ragged inner surface of the makeshift "grommet fits snugly 360 [degrees] on the cable." In fact, the grommet could slip both relative to the cable and relative to its outside manufactured (wrong size) grommet; as well as, not providing anything close to a "snug fit. In fact, these added-up fabrication-construction deficiencies, badly compromised the cable retention design methodology.

Shown above, is page 2 of the Installation Guide that was supplied with the connector components (refer to comments in paragraph 3-10 concerning connector and cable fabrication irregularities).

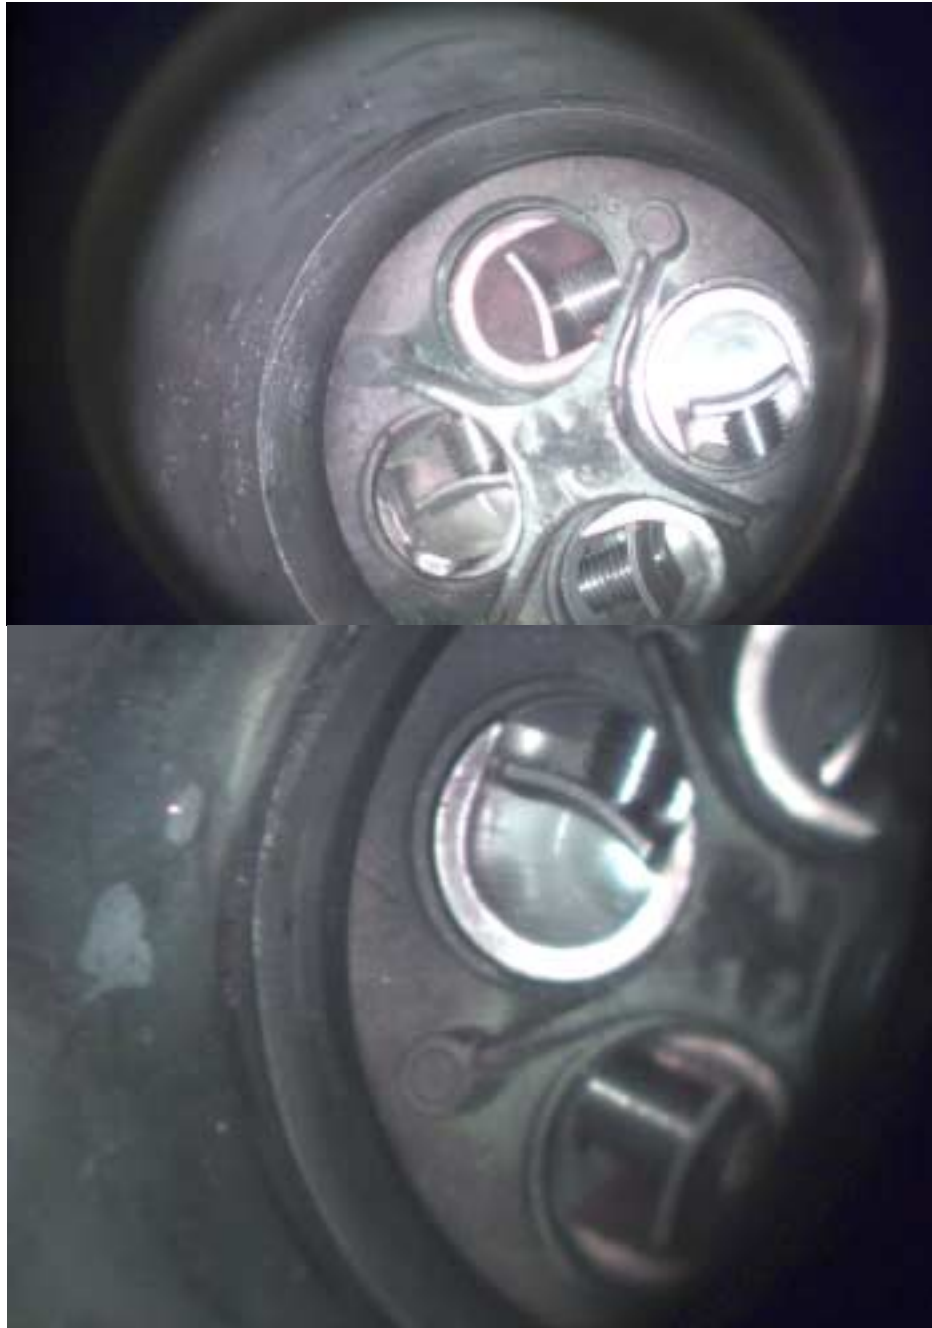
Figure 14

- 3.11 The connector was disassembled and it was noted that there were debris fields of spherical copper balls with the metal embedded (by force) into the sides of the inner cavity. The greater number of small "projectile" debris (see Figure 14, top photo) can be seen in the area of pin 4G and pin 1 to its left. These are the clamp holes for the pins where the initial shorting is assumed to have taken place. See also, the photo in Figure 9 that better shows the greater burn damages in that same area. There is a larger spherical copper ball embedded in the side (beside pin 3) of the inner connector cavity (see Figure 9, below the smallest arrow). If the ball had been deposited by a flash from the major arc burn area, then it would have had to pass thru two wires. Most likely, this sphere was deposited by ionization of the copper ground conductor.

These photos show the debris fields of spherical copper balls on the sides of the inner cavity. Note the greater number of small debris (top photo) in the area of pin 4G (the darker clamp hole) and pin 1 to its left. Note also, that there is a larger spherical copper ball embedded in the side (above pin 3) of the inner connector cavity. See paragraph 3.13.2 discussion. Magnification: oblique views
